**Flood Control Project Maintenance
Levee Inspections**

Maintenance Issue Types Only, Levee Inspection Report By Mile - Spring 2017

Reclamation District No. 1500 Sutter Basin

Waterway	Bank	Unit Miles	Inspection Start/End	Inspector
Unit No. 01 Sacramento River	Left	33.15	05/09/2017 05/16/2017	Zach Jojola

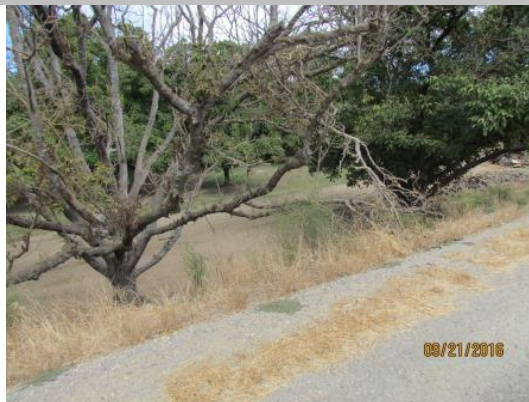
Photo 1 of 1 : SP_2017_RD1500_189_137_20170320_00090.jpg

LM Start	0.07	Rating **	M	Issue No.	137
LM End	0.07	Issue Type +	Ma	Location *	LS
Category	Earthen Levee		GPS Latitude/Longitude		
			Start	End	
Item	Trim / Thin Trees		38.761077 °	38.761077 °	
			-121.675851 °	-121.675851 °	
DWR ID	DWR_RD1500_01_f_2016_137				
Comment Code					
T1 : Trim trees to at least five feet above ground level.					
Inspector Comment

A tree on landside slope needs trimming. Fall 2016.

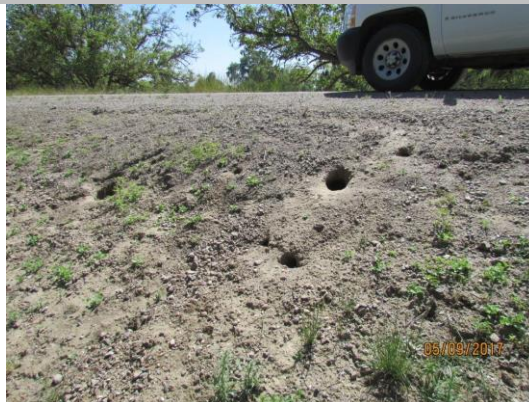
Photo 1 of 1 : SP_2017_RD1500_189_155_20170516_00258.jpg

LM Start	0.26	Rating **	M	Issue No.	155
LM End	0.26	Issue Type +	Ma	Location *	LS
Category	Earthen Levee		GPS Latitude/Longitude		
			Start	End	
Item	Animal Control		38.762584 °	38.762584 °	
			-121.678542 °	-121.678542 °	
DWR ID	DWR_RD1500_01_s_2017_155				
Comment Code					
A3 : No rodents visible, but rodent burrows visible; need to backfill and compact or grout burrows.					
Inspector Comment

View of rodent holes on landside slope. Spring 2017.

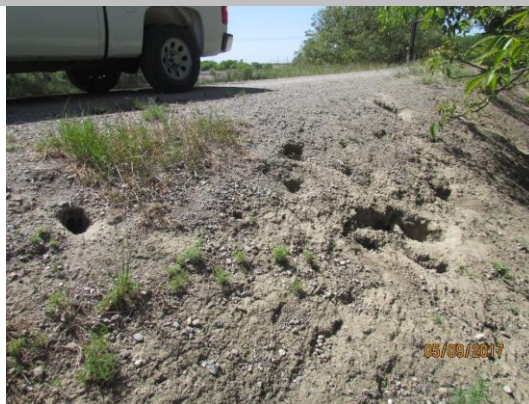
Photo 1 of 1 : SP_2017_RD1500_189_152_20170516_00256.jpg

View of rodent holes on landside slope. Spring 2017.

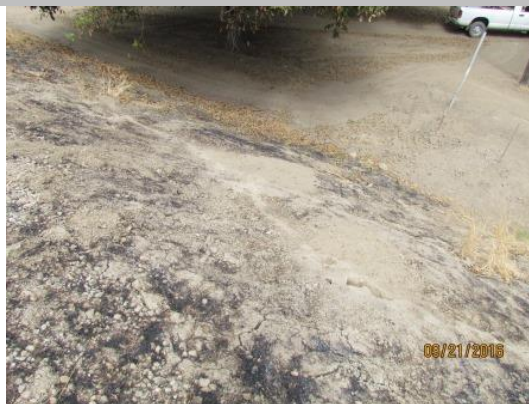
Photo 1 of 1 : SP_2017_RD1500_189_135_20170320_00088.jpg

LM Start	0.32	Rating **	M	Issue No.	135
LM End	0.32	Issue Type +	Ma	Location *	LS
Category	Earthen Levee			GPS Latitude/Longitude	
				Start	End
Item	Animal Control			38.763267 °	38.763267 °
				-121.679050 °	-121.679050 °
DWR ID	DWR_RD1500_01_f_2016_135				
Comment Code					
A3 : No rodents visible, but rodent burrows visible; need to backfill and compact or grout burrows.					
Inspector Comment

Rodent activity on LS slope. Fall 2016.

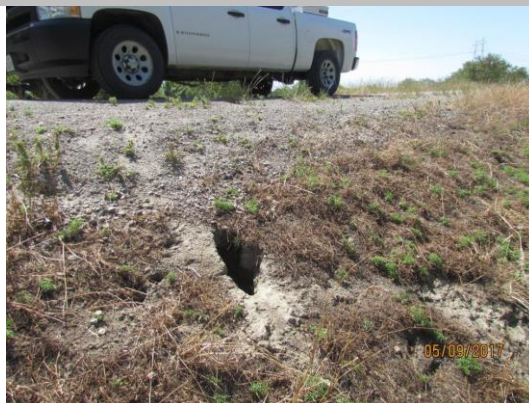
Photo 1 of 1 : SP_2017_RD1500_189_151_20170516_00257.jpg

View of rodent holes on landside slope. Spring 2017.

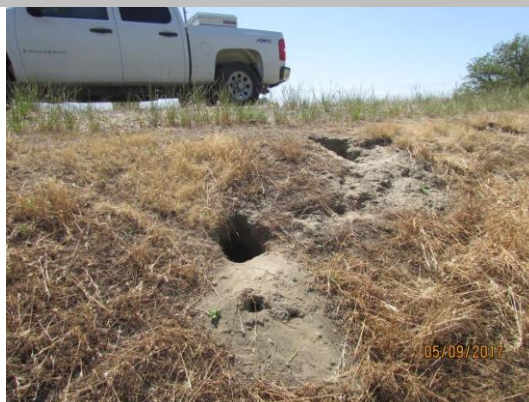
Photo 1 of 1 : SP_2017_RD1500_189_149_20170516_00254.jpg

LM Start	0.37	Rating **	M	Issue No.	149
LM End	0.37	Issue Type +	Ma	Location *	LS
Category	Earthen Levee			GPS Latitude/Longitude	
				Start	End
Item	Animal Control			38.763826 °	38.763826 °
				-121.679787 °	-121.679787 °
DWR ID	DWR_RD1500_01_s_2017_149				
Comment Code					
A3 : No rodents visible, but rodent burrows visible; need to backfill and compact or grout burrows.					
Inspector Comment

View of rodent holes on landside slope. Spring 2017.

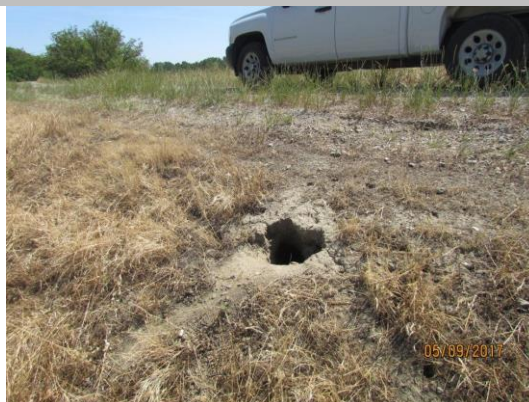
Photo 1 of 1 : SP_2017_RD1500_189_148_20170516_00253.jpg

LM Start	0.38	Rating **	M	Issue No.	148
LM End	0.38	Issue Type +	Ma	Location *	LS
Category	Earthen Levee			GPS Latitude/Longitude	
				Start	End
Item	Animal Control			38.763913 °	38.763913 °
				-121.679946 °	-121.679946 °
DWR ID	DWR_RD1500_01_s_2017_148				
Comment Code					
A3 : No rodents visible, but rodent burrows visible; need to backfill and compact or grout burrows.					
Inspector Comment

View of rodent hole on landside slope. Spring 2017.

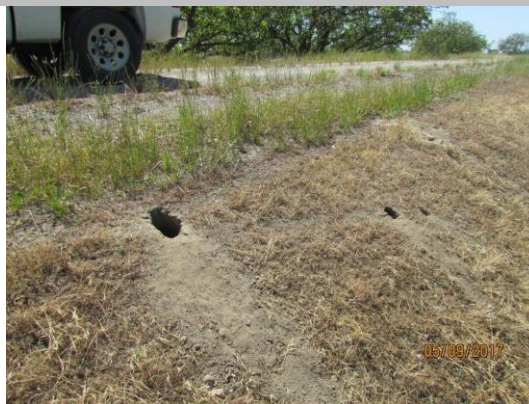
Photo 1 of 1 : SP_2017_RD1500_189_147_20170516_00252.jpg

View of rodent holes on landside slope. Spring 2017.

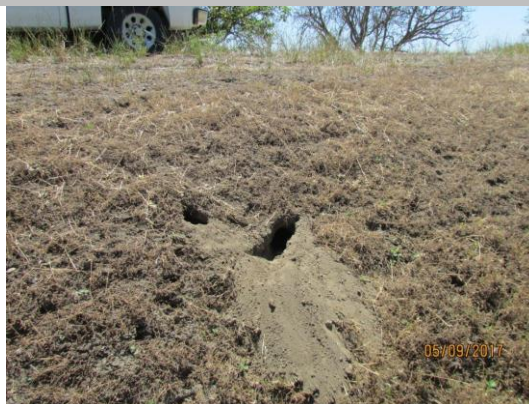
Photo 1 of 1 : SP_2017_RD1500_189_133_20170516_00251.jpg

LM Start	0.46	Rating **	M	Issue No.	133
LM End	0.46	Issue Type +	Ma	Location *	LS
Category	Earthen Levee			GPS Latitude/Longitude	
				Start	End
Item	Animal Control			38.764380 °	38.764380 °
				-121.681212 °	-121.681212 °
DWR ID	DWR_RD1500_01_s_2017_133				
Comment Code					
A3 : No rodents visible, but rodent burrows visible; need to backfill and compact or grout burrows.					
Inspector Comment

View of rodent holes on landside slope. Spring 2017.

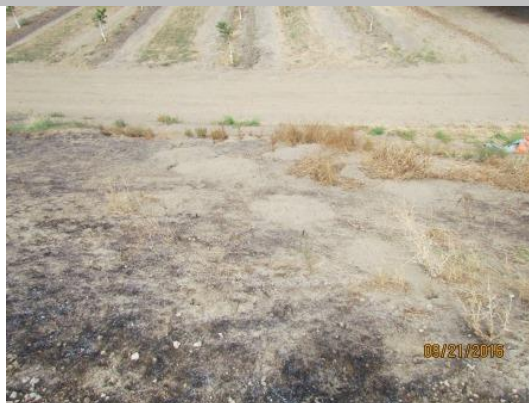
Photo 1 of 1 : SP_2017_RD1500_189_134_20170320_00087.jpg

Rodent burrows on LS slope. Fall 2016.

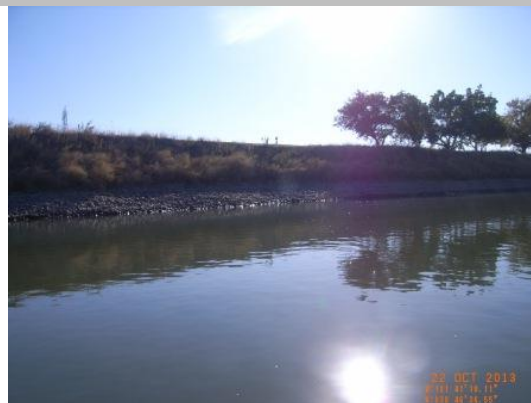
Photo 1 of 1 : SP_2017_RD1500_189_6_20170320_00006.jpg

LM Start	1.34	Rating **	A/W	Issue No.	6
LM End	1.95	Issue Type +	Ma	Location *	WS
Category	Supplemental			GPS Latitude/Longitude	
				Start	End
Item	2015 USACE Erosion Survey, DRAFT			38.770390 °	38.777282 °
				-121.690553 °	-121.685841 °
DWR ID	DWR_RD1500_01_s _ 2016_6				
Comment Code					
Inspector Comment					
2006 - New erosion upstream, new bank failures near levee but still fairly wide berm in most places. 2008 - Large berm, questionable as to if it should remain in the inventory. 2010 - Minor new erosion, old cobble starting to fail. 2011 - Cobble continues to unravel and additional slumping. 2012 - Minor new erosion at bank mid point. 2013 - Minor new erosion. 2015: No observed changes. [2015 Site ID: SAC 86-3 L]

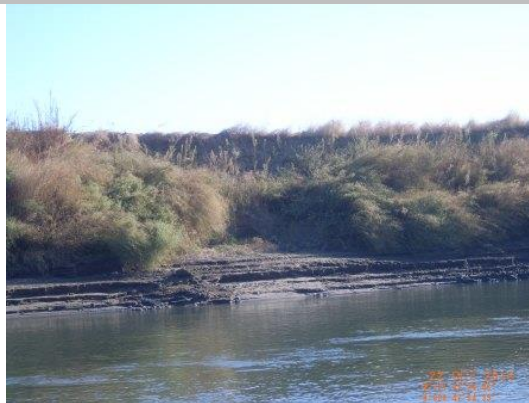
Photo 1 of 1 : SP_2017_RD1500_189_2_20170320_00002.jpg

LM Start	2.30	Rating **	A/W	Issue No.	2
LM End	2.52	Issue Type +	Ma	Location *	WS
Category	Supplemental			GPS Latitude/Longitude	
				Start	End
Item	2015 USACE Erosion Survey, DRAFT			38.781962 °	38.784936 °
				-121.688033 °	-121.690033 °
DWR ID	DWR_RD1500_01_s _ 2016_2				
Comment Code					
Inspector Comment					
2010 - The upstream end of the repair site at 87.0. Repair did not extend far enough upstream. 2011 - New erosion pockets. 2012 - Minor new erosion at toe. 2013 - Minor new erosion. 2015: Significant new toe erosion. [2015 Site ID: SAC_87-1_L]

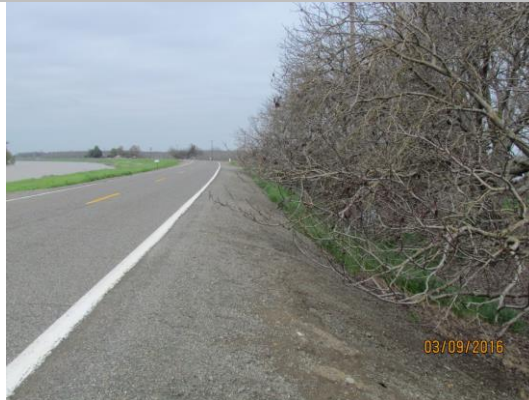
Photo 1 of 1 : SP_2017_RD1500_189_217_20170320_00097.jpg

View of the trees on the landward side of the levee looking upstream.
Spring 2016.

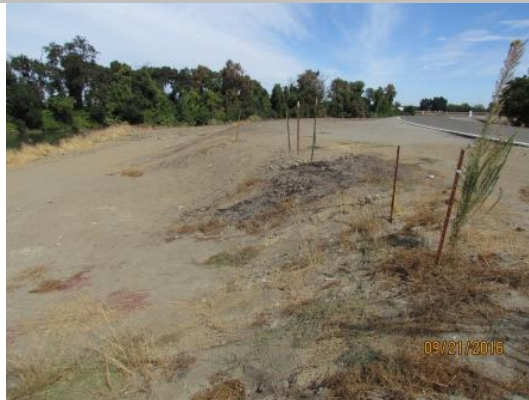
Photo 1 of 2 : SP_2017_RD1500_189_150_20170320_00093.jpg

LM Start	8.29	Rating **	M	Issue No.	150
LM End	8.29	Issue Type +	Ma	Location *	WS
Category	Earthen Levee			GPS Latitude/Longitude	
				Start	End
Item	Erosion / Bank Caving			38.838802 °	38.838802 °
				-121.729598 °	-121.729598 °
DWR ID	DWR_RD1500_01_s_2016_150				
Comment Code					
E2 : Schedule repair of erosion site prior to the next inspection.					
Inspector Comment					
Erosion caused by vehicles and runoffs from rain.

Updated view of the erosion site on waterward side of the levee. Fall 2016.

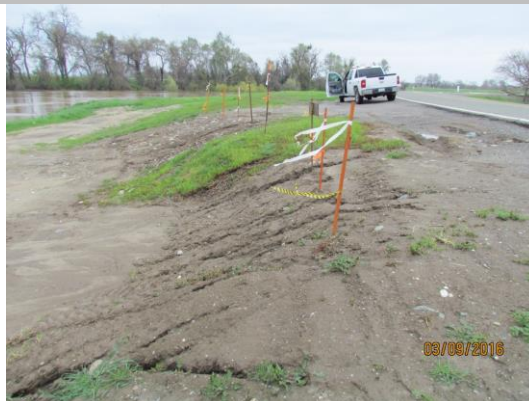
Photo 2 of 2 : SP_2017_RD1500_189_150_20170320_00094.jpg

LM Start	8.29	Rating **	M	Issue No.	150 (cont)
LM End	8.29	Issue Type +	Ma	Location *	WS
Category	Earthen Levee			GPS Latitude/Longitude	
				Start	End
Item	Erosion / Bank Caving			38.838802 °	38.838802 °
				-121.729598 °	-121.729598 °
DWR ID	DWR_RD1500_01_s_2016_150				
Comment Code					
E2 : Schedule repair of erosion site prior to the next inspection.					
Inspector Comment					
Erosion caused by vehicles and runoffs from rain.

View of the erosion on the waterward side of the levee looking upstream. Spring 2016.

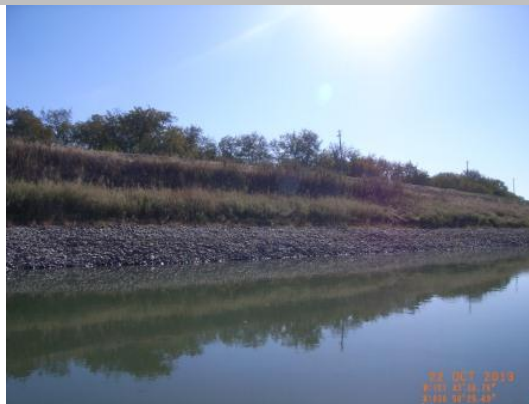
Photo 1 of 1 : SP_2017_RD1500_189_3_20170320_00003.jpg

LM Start	8.33	Rating **	M	Issue No.	3
LM End	8.47	Issue Type +	Ma	Location *	WS
Category	Supplemental			GPS Latitude/Longitude	
				Start	End
Item	2015 USACE Erosion Survey, DRAFT			38.839546 °	38.840347 °
				-121.729591 °	-121.726857 °
DWR ID	DWR_RD1500_01_s_2016_3				
Comment Code					
Inspector Comment					
1997 - Damage to cobble revetment on top left bank and toe damage. 2004 - Site is pretty minor. 2010 - Cobbles continue to deteriorate. 2011 - Minor new erosion at the toe. 2013 - Might be able to shorten due to deposition. 2015: Site shortened, downstream end has plenty of berm and deposited material, well vegetated. [2015 Site ID: SAC_92-8_L]

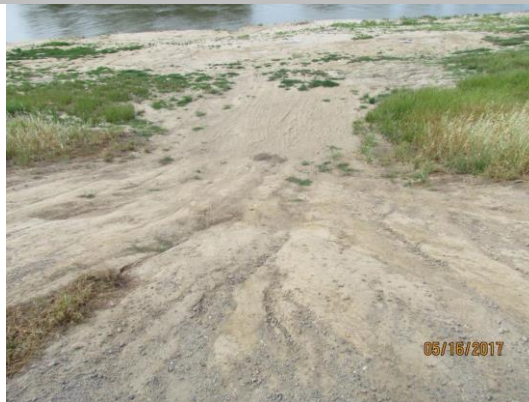
Photo 1 of 1 : SP_2017_RD1500_189_162_20170516_00259.jpg

LM Start	9.71	Rating **	A/W	Issue No.	162
LM End	9.71	Issue Type +	Ma	Location *	WS
Category	Earthen Levee			GPS Latitude/Longitude	
				Start	End
Item	Slope Stability			38.853564 °	38.853564 °
				-121.725379 °	-121.725379 °
DWR ID	DWR_RD1500_01_s_2017_162				
Comment Code					
S3 : Repair the levee slope damaged by vehicle traffic and prevent access where possible.					
Inspector Comment					
Heavily accessed area for fishing. Recommend monitoring.

View of slope stability on waterside slope. Spring 2017.

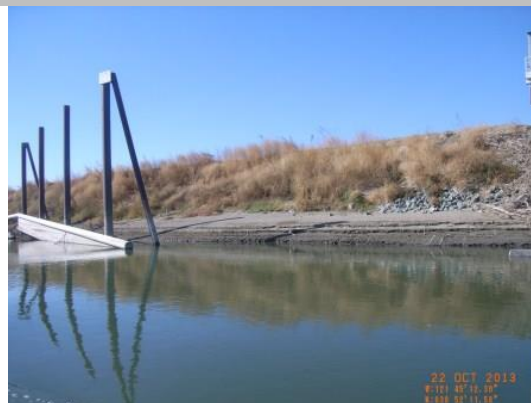
Photo 1 of 1 : SP_2017_RD1500_189_1_20170320_00001.jpg

LM Start	11.99	Rating **	A/W	Issue No.	1
LM End	12.26	Issue Type +	Ma	Location *	WS
Category	Supplemental			GPS Latitude/Longitude	
				Start	End
Item	2015 USACE Erosion Survey, DRAFT			38.870474 °	38.869139 °
				-121.752237 °	-121.757108 °
DWR ID	DWR_RD1500_01_s_2016_1				
Comment Code					
Inspector Comment					
2000 - Vertical Modesto Formation bank with mass failure. 2003 - Upstream end has some new bank retreat. 2004 - Upstream end is worse. 2006 - Some new erosion, mainly on the steep slope and scarps. (Pumping station is not part of the erosion site.) 2010 - Some new erosion and deposition at upstream end, definite encroachments. 2011 - Minor new erosion at the toe. 2015: Site removed, sufficient berm width. [2015 Site ID: SAC_96-2_L]

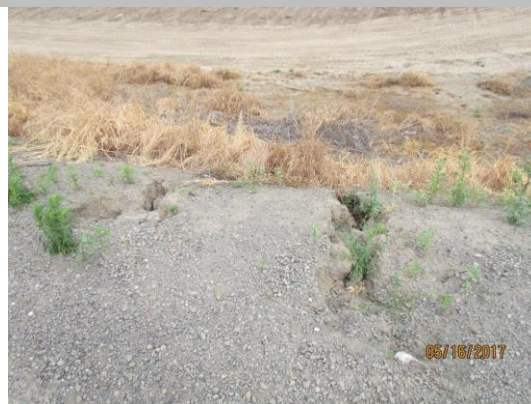
Photo 1 of 1 : SP_2017_RD1500_189_116_20170516_00260.jpg

LM Start	12.01	Rating **	M	Issue No.	116
LM End	12.01	Issue Type +	Ma	Location *	LS
Category	Earthen Levee			GPS Latitude/Longitude	
				Start	End
Item	Erosion / Bank Caving			38.870730 °	38.870730 °
				-121.752908 °	-121.752908 °
DWR ID	DWR_RD1500_01_s_2017_116				
Comment Code					
E2 : Schedule repair of erosion site prior to the next inspection.					
Inspector Comment					
Runoff erosion on landside levee slope.

View of erosion on landside slope. Spring 2017.

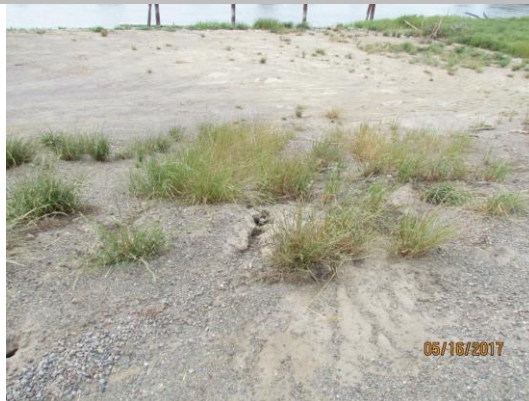
Photo 1 of 1 : SP_2017_RD1500_189_168_20170516_00261.jpg

LM Start	12.06	Rating **	M	Issue No.	168
LM End	12.06	Issue Type +	Ma	Location *	WS
Category	Earthen Levee			GPS Latitude/Longitude	
				Start	End
Item	Erosion / Bank Caving			38.870439 °	38.870439 °
				-121.753710 °	-121.753710 °
DWR ID	DWR_RD1500_01_s_2017_168				
Comment Code					
E2 : Schedule repair of erosion site prior to the next inspection.					
Inspector Comment					
Runoff erosion on waterside levee slope.

View of erosion on waterside slope. Spring 2017.

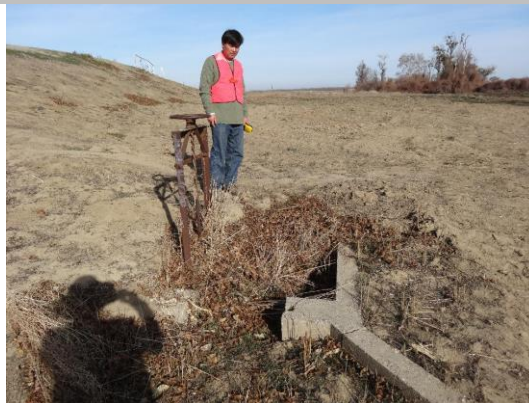
Photo 1 of 3 : UCIP_SP_2017_50197_52425.jpg

FS_ID:50197
DS_ID:20063
EP_NO: 10061
Repair Type: Non-Urgent
Crossing Status: Found
UCIP Comments: 08/29/2016 Same as last inspection. (K. Fazel - UCIP)01/10/2014 Needs proper abandonment. (P. Amatya - DWR)
FIELD_STRUCT_DESC: *ABANDONED* 18-inch corrugated metal drainage pipe through the levee, 15 feet below the crown. Slide gate in 4-foot by 4-foot concrete box at the waterside (WS) toe. Concrete box at the landside (LS) toe. Pipe crosses overflow area to the river.
(Automatic Board Order (ABO) issued as Permit No. 10061, 1974 - Matteoli). [Additional Reference(s): DWR Levee Log, 2005. USACE Sacramento O&M Manual 128, March 1960 (HLM 12.69)].
FS Date: 8/29/2016

WS view: slide gate (left) in concrete box at levee toe. Slide gate and the box mostly burried.

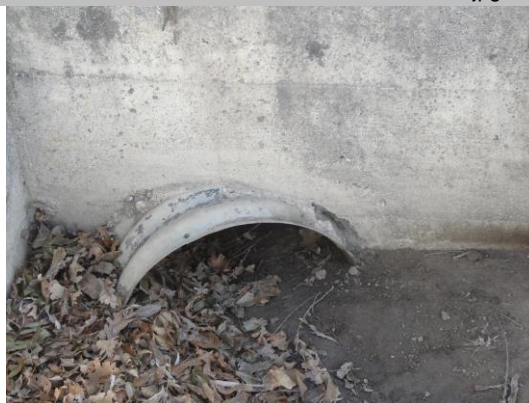
Photo 3 of 3 : UCIP_SP_2017_50197_52423.jpg

Item	DWR UCIP LMA Responsibility			38.867254 °		38.867254 °
				-121.761212 °		-121.761212 °
DWR ID						
Comment Code						
Inspector Comment						
FS_ID:50197 DS_ID:20063 EP_NO: 10061 Repair Type: Non-Urgent Crossing Status: Found UCIP Comments: 08/29/2016 Same as last inspection. (K. Fazel - UCIP)01/10/2014 Needs proper abandonment. (P. Amatya - DWR) FIELD_STRUCT_DESC: *ABANDONED* 18-inch corrugated metal drainage pipe through the levee, 15 feet below the crown. Slide gate in 4-foot by 4-foot concrete box at the waterside (WS) toe. Concrete box at the landside (LS) toe. Pipe crosses overflow area to the river. (Automatic Board Order (ABO) issued as Permit No. 10061, 1974 - Matteoli). [Additional Reference(s): DWR Levee Log, 2005. USACE Sacramento O&M Manual 128, March 1960 (HLM 12.69)]. FS Date: 8/29/2016

LS view: silted CMP in concrete intake box on levee toe.

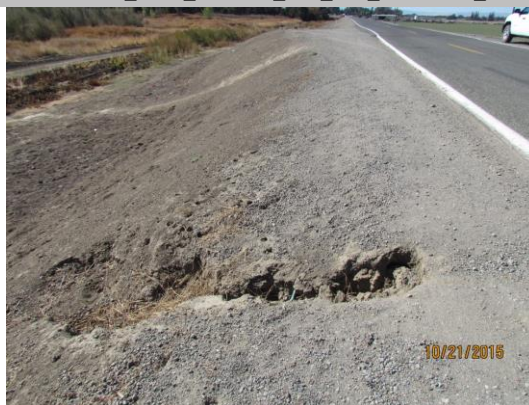
Photo 1 of 1 : SP_2017_RD1500_189_118_20170320_00076.jpg

LM Start	12.57	Rating **	M	Issue No.	118
LM End	12.57	Issue Type +	Ma	Location *	WS
Category	Earthen Levee			GPS Latitude/Longitude	
				Start	End
Item	Erosion / Bank Caving			38.867108 °	38.867108 °
				-121.761498 °	-121.761498 °
DWR ID	DWR_RD1500_01_f_2015_118				
Comment Code					
E2 : Schedule repair of erosion site prior to the next inspection.					
Inspector Comment

View of the erosion on the waterward side of the levee looking upstream. Fall 2015.

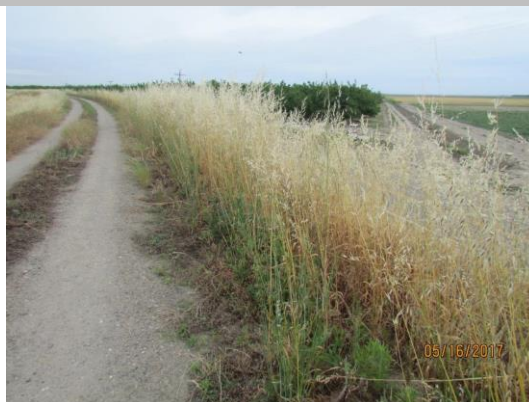
Photo 1 of 1 : SP_2017_RD1500_189_77_20170516_00262.jpg

Tall grass on landside levee slope, blocking visibility. Spring 2017.

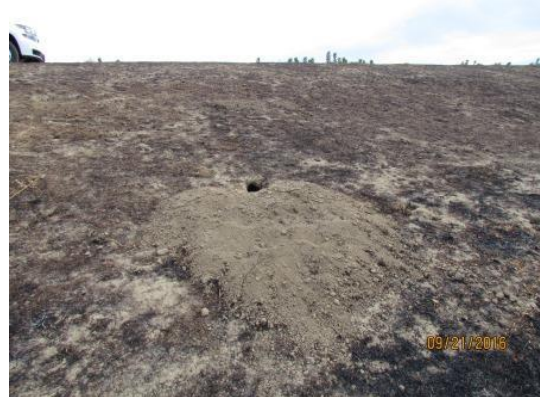
Photo 1 of 1 : SP_2017_RD1500_189_120_20170320_00078.jpg

View of rodent burrow on waterward side of the levee. Fall 2016.

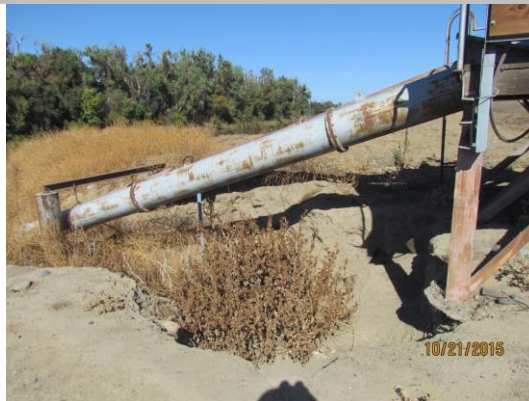
Photo 2 of 3 : SP_2017_RD1500_189_121_20170320_00080.jpg

There is erosion underneath the pipe on the waterward berm area. Fall 2015.

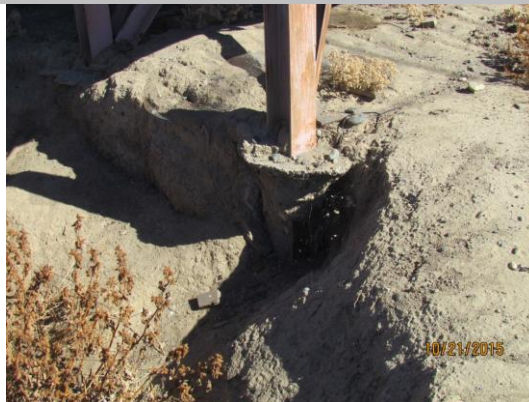
Photo 3 of 3 : SP_2017_RD1500_189_121_20170320_00081.jpg

The concrete for the base stand has been exposed due to erosion.

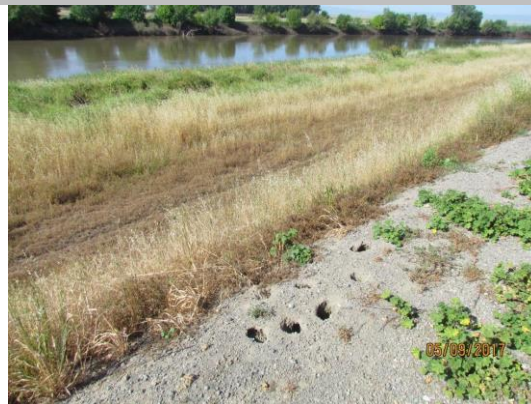
Photo 1 of 1 : SP_2017_RD1500_189_95_20170516_00249.jpg

View of rodent holes on waterside shoulder. Spring 2017.

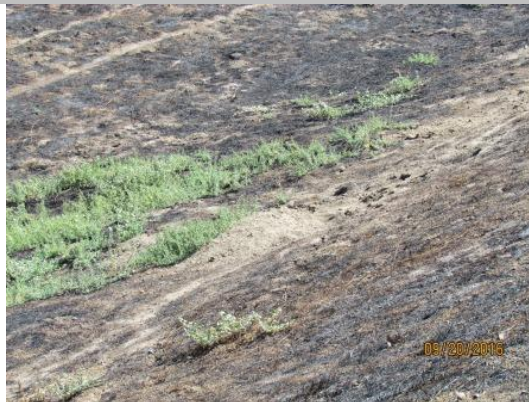
Photo 1 of 3 : SP_2017_RD1500_189_102_20170320_00058.jpg

A number of burrows was observed at this site on landward slope. Fall 2016.

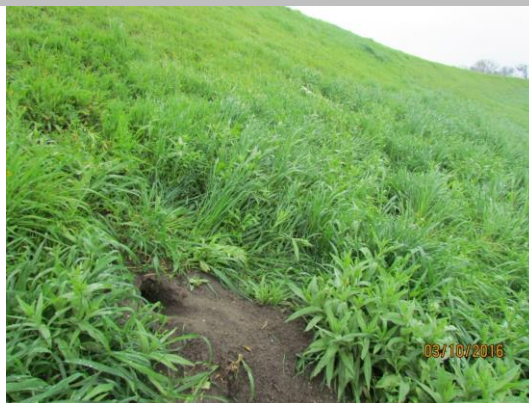
Photo 3 of 3 : SP_2017_RD1500_189_102_20170320_00060.jpg

View of rodent hole on the landward side of the levee looking upstream.
Spring 2016.

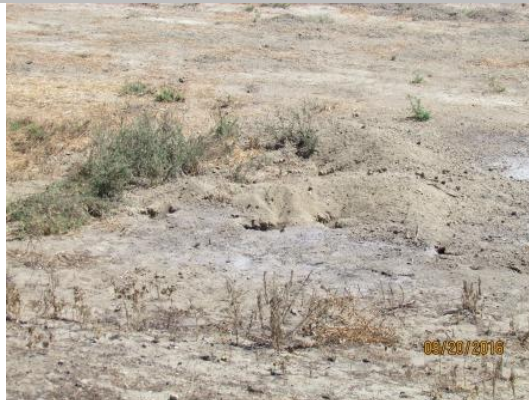
Photo 1 of 1 : SP_2017_RD1500_189_104_20170320_00061.jpg

More than 2 cu.ft. of soil was observed around burrows on LS slope of the levee. Fall 2016.

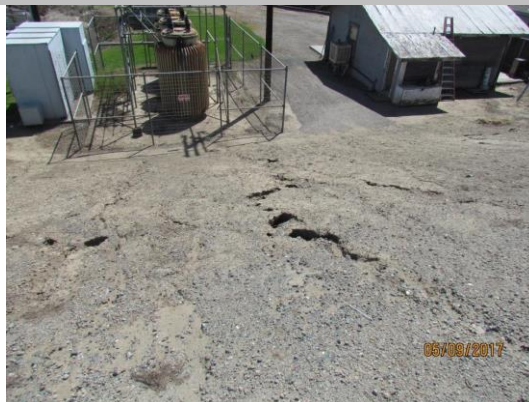
Photo 1 of 1 : SP_2017_RD1500_189_144_20170516_00250.jpg

View of erosion on landside slope. Spring 2017.

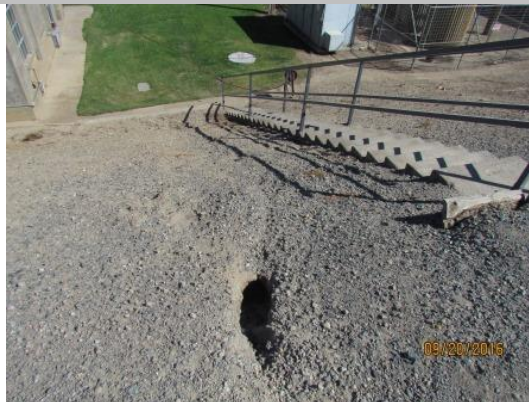
Photo 1 of 1 : SP_2017_RD1500_189_107_20170320_00064.jpg

View of rodent burrows on landside slope. Fall 2016.

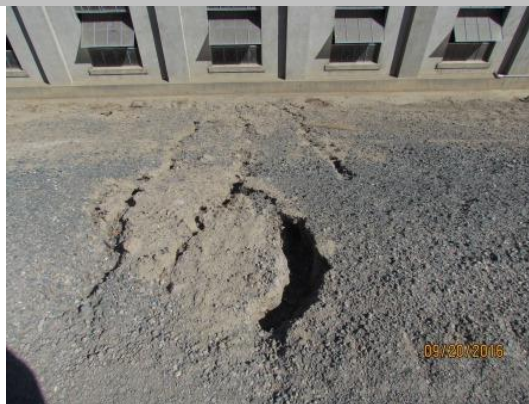
Photo 1 of 1 : SP_2017_RD1500_189_106_20170320_00063.jpg

View of erosion site on LS slope of the levee. Fall 2016.

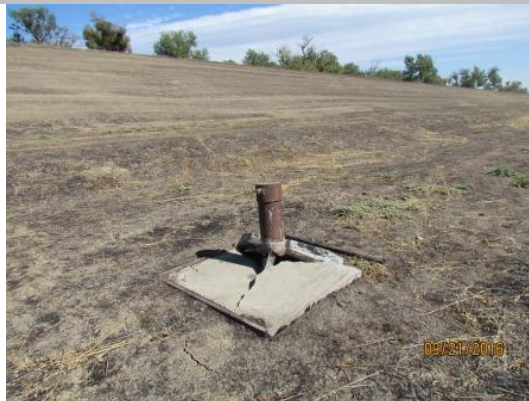
Photo 1 of 3 : SP_2017_RD1500_190_4_20170320_00002.jpg

View of underseepage relief well. Concrete pad as well as PVC pipes underneath are destroyed apparently by an attempt to pull out the head of the well. Fall 2016.

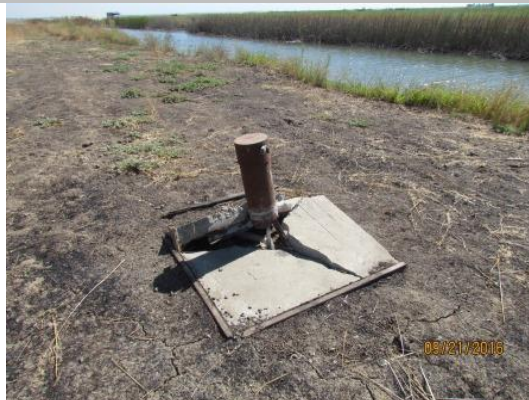
Photo 2 of 3 : SP_2017_RD1500_190_4_20170320_00003.jpg

Another view of damaged well. Fall 2016.
